Arboricultural Impact Assessment

- Tree Survey
- Tree Protection Plan
- Preliminary Arboricultural
Method Statement

The Lodge
Long Lane
London
N3 2PY

Survey Date: 27th January 2017
Report Date: 6th June 2017
Project no: 992

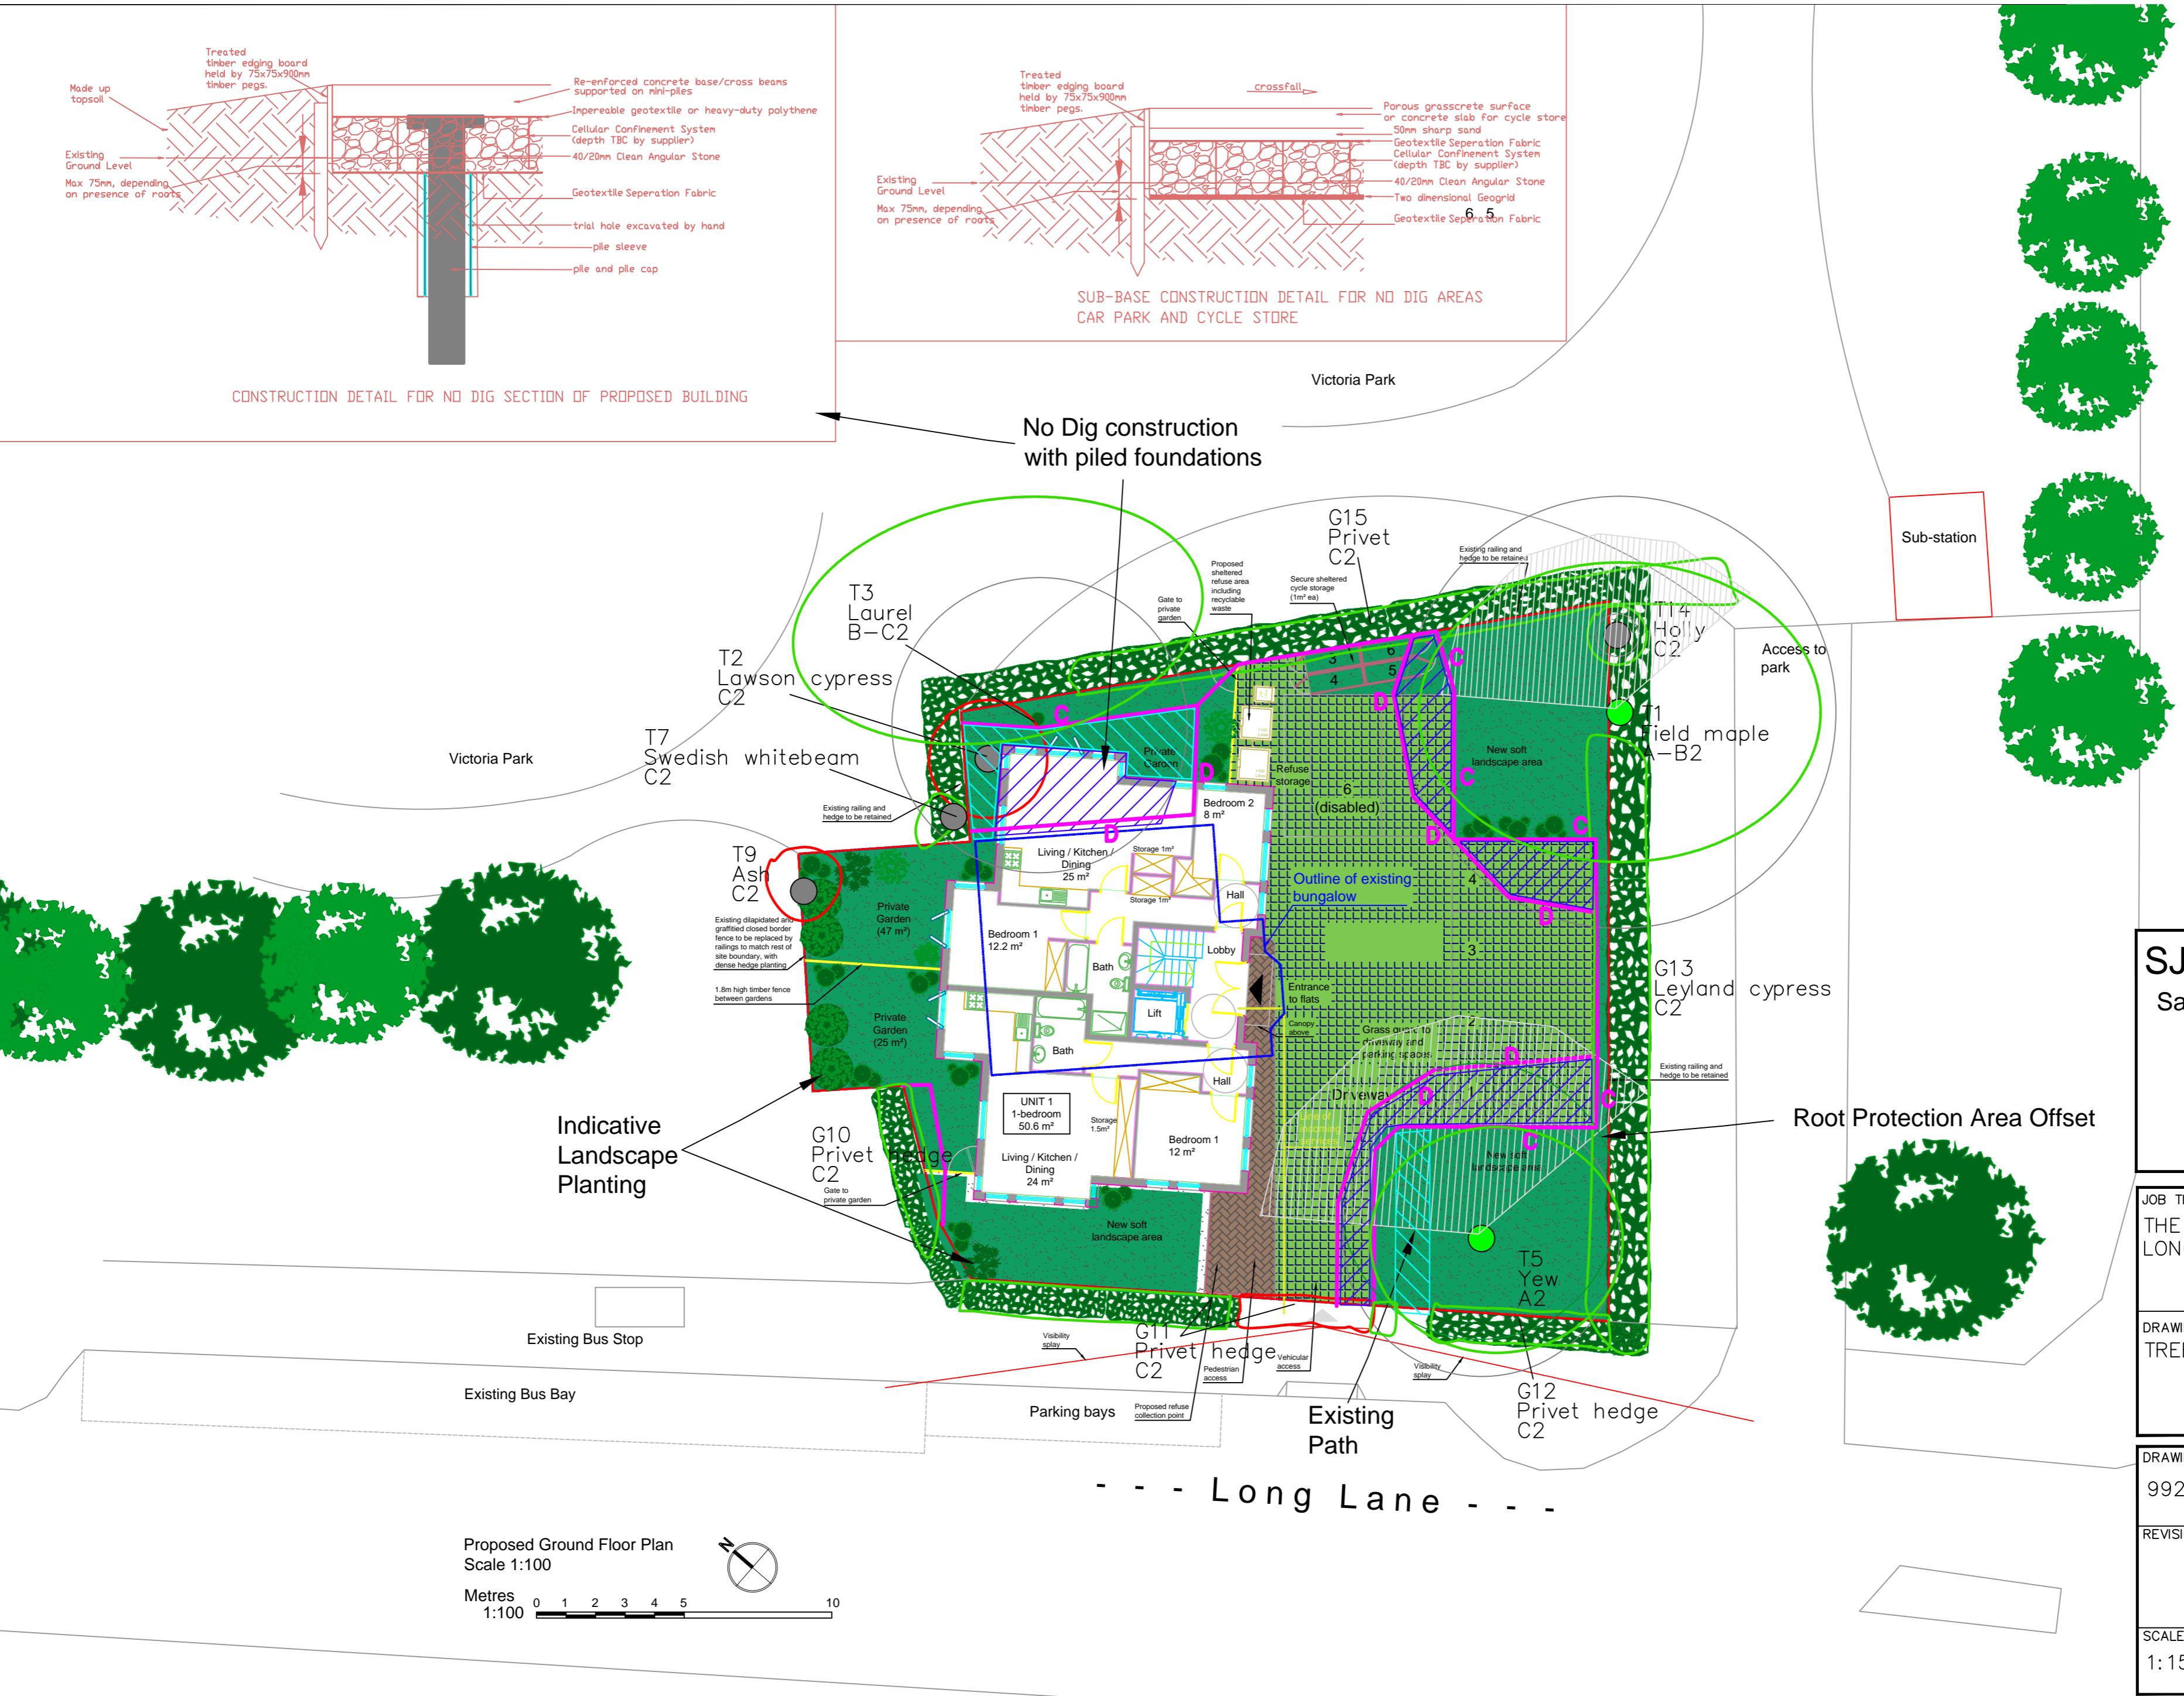
DRAWING NUMBER	992-01	REV	B
REVISIONS			
SCALE	1:150 at A2	DATE	JUN 17
DRAWN BY	sjss

- 4.4.2 The Root Protection Area for the yew (T5) has been offset away from the road, since it is likely that more roots will be within the garden than under the road.

- 5.3 Protection measures have been specified to protect all retained trees, including No-Dig construction for sections of the car park and building. New hard surfacing will cover approximately 16m², or 12.5%, of the un-surfaced part of the Root Protection Area of the field maple, T1. This is well within the 20% maximum recommended in BS5837.

- 5.4 New hard surfacing will also cover 14m² or approximately 20% of the Root Protection Area of the yew, T5. Although this is the maximum recommended in BS5837, since new surfacing will be permeable, it is unlikely to affect the long-term health of the tree.

- 4.4.3 The location of Tree Protection Fencing is shown on the drawing attached as Appendix A. This provides full protection of all Root Protection Areas, other than for:

- 4.4.5 Tree Protection Fencing must initially be erected around the outer perimeter of the No-Dig areas, where indicated "D" on the drawing, then moved to the inner perimeter, where indicated "C" as work on that particular area commences.

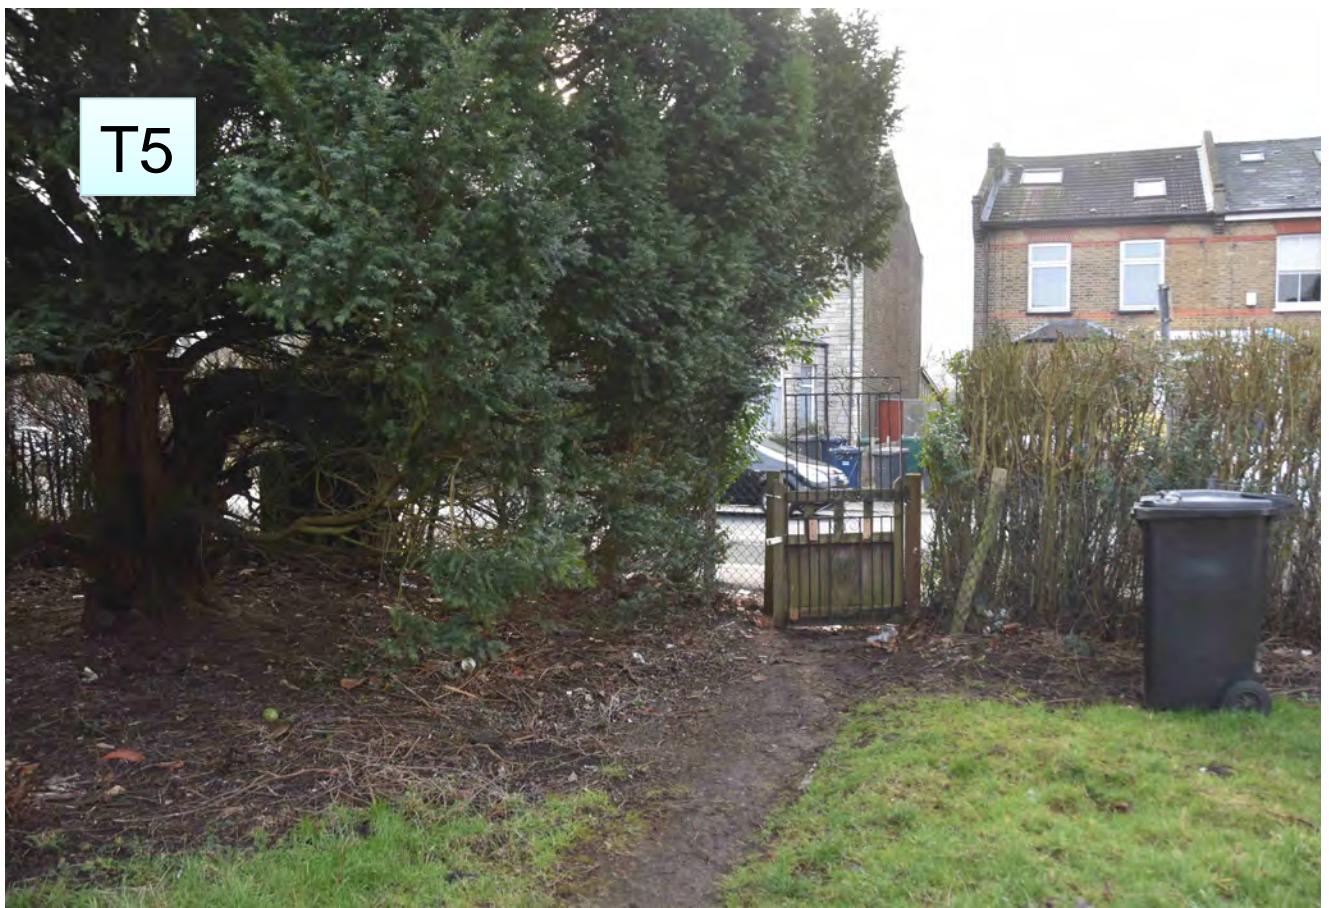
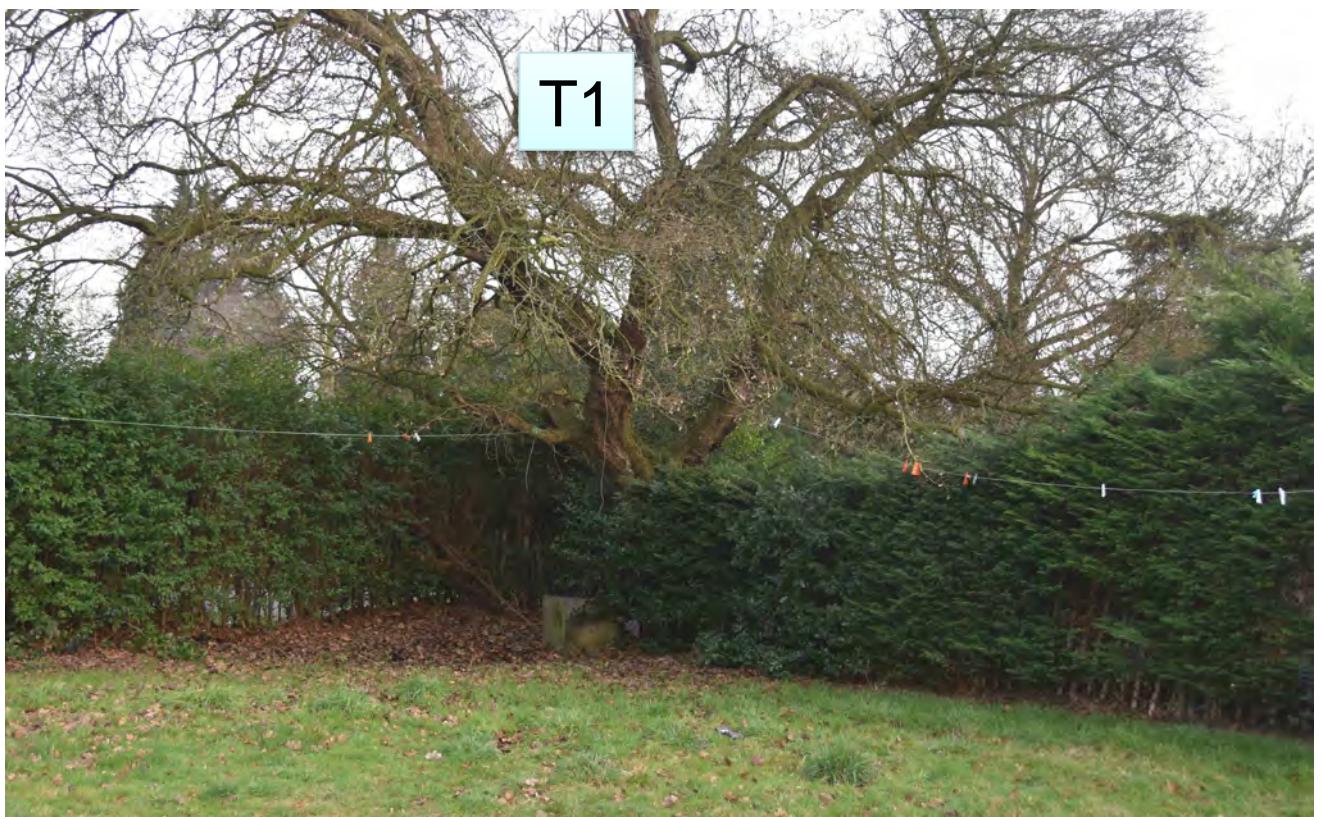
Appendix Ei)

- 4.1.3 There are two high quality trees, protected by Tree Preservation Orders, on the site. T1 is a mature field maple growing just outside the site, but leaning into it. This is an attractive tree of great character, which could develop into a future veteran. T4 is a younger yew, showing good vigour and in a prominent location on the corner of the entrance to the park, and which has the potential to grow on for a considerable period. There is also a multi-stemmed laurel, T3, which is growing over into, and adding to the overall character of the park. It is also providing good evergreen screening between the park and the site and, therefore, although it is not a high quality tree, we have suggested that it is retained. These trees are shown in the photos included in Appendix E. Other trees and hedges within the site, while providing screening, are of far less importance.
