# Brent Cross Development

Area Wide Walking and Cycling Study  
Addendum  
47065005-TP-RPT-070  
Rev 1

## Area Wide Walking and Cycling Study - Addendum

Doc. No: 47065005-TP-RPT-070

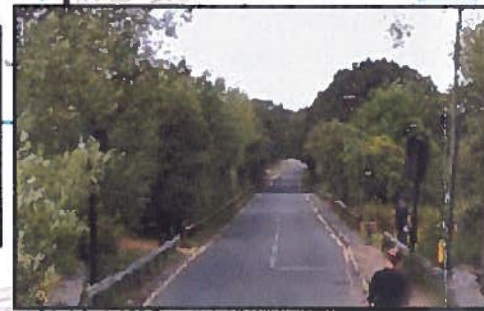
Off-road path entrance to Cool Oak Lane

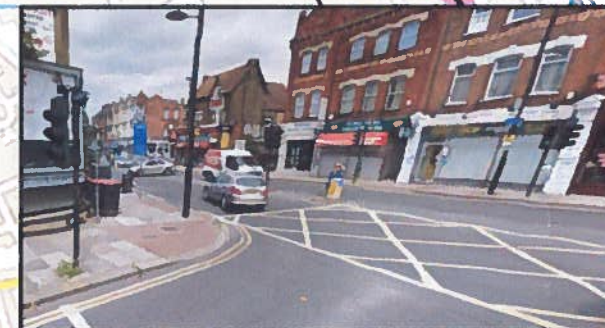
A5 West Hendon Broadway between Cool Oak Lane and Park Road

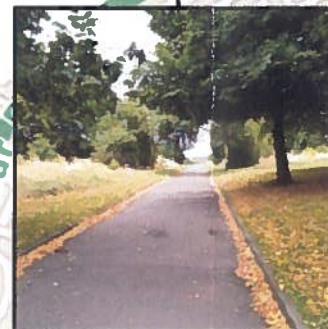
Existing path through Welsh Harp

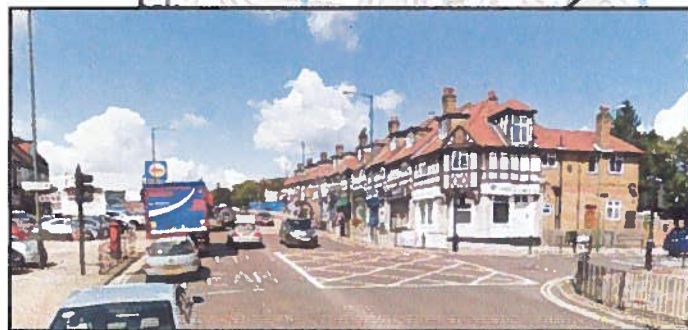
Junction of Blackbird Hill and Birchen Grove
