## Fire Risk Assessment Regulatory Reform (Fire Safety) Order 2005

### Office Property

**LB Barnet Offices,  
2 Bristol Avenue,  
Colindale,  
NW9 4EW**

**Client: London Borough Barnet**

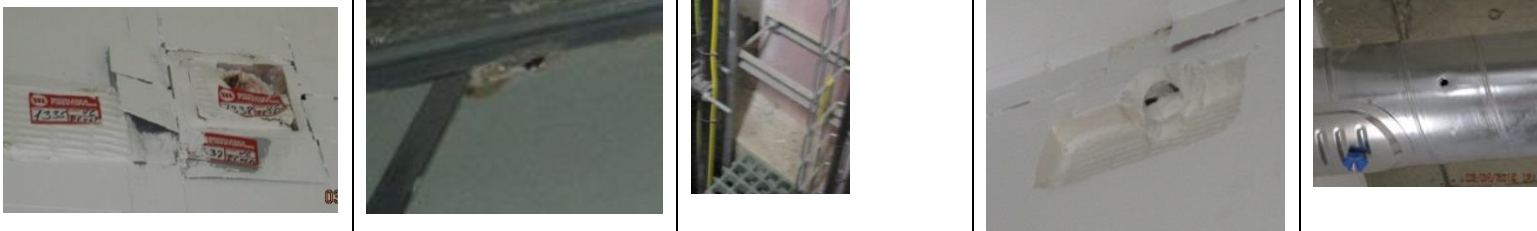
| Category | Hazards Introduced by Contractors | Priority | 2 |
|---|---|---|---|
| Location | The opening in the specified areas for the passage of the service pipes or cables must be adequately sealed with fire resisting material in order to minimize the danger of the spread of heat, smoke and fumes. | | |
| Control Action Recommended | 8 <sup>th</sup> floor South Comms cupboard, fire stopping above doors; 6 <sup>th</sup> floor North, air con riser above doors; 5 <sup>th</sup> floor electrical riser hole in wall (low down towards lift side); 3 <sup>rd</sup> floor North, Comms riser, mastic slumped from sprinkler pipe hole; 3 <sup>rd</sup> floor electrical riser hole in wall (low down towards lift side); 2 <sup>nd</sup> floor North gas pipe riser hole around flexi pipe; 2 <sup>nd</sup> floor North, Comms riser, mastic slumped from sprinkler pipe hole; Ground floor Comms room, hole around data cable above door; Seal puncture hole in duct, ground floor escape corridor from secondary stairway | | |
