## Fire Risk Assessment Regulatory Reform (Fire Safety) Order 2005

### Office Property

**LB Barnet Offices,  
2 Bristol Avenue,  
Colindale,  
NW9 4EW**

**Client: London Borough Barnet**

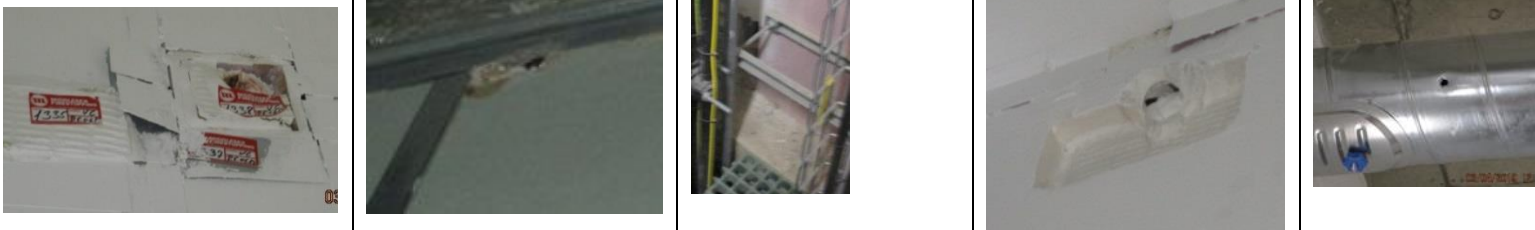
Category	Hazards Introduced by Contractors	Priority	2
Identified Hazard	Fire stopping to required standards		
Location	The opening in the specified areas for the passage of the service pipes or cables must be adequately sealed with fire resisting material in order to minimize the danger of the spread of heat, smoke and fumes.		
Control Action Recommended	8 <sup>th</sup> floor South Comms cupboard, fire stopping above doors; 6 <sup>th</sup> floor North, air con riser above doors; 5 <sup>th</sup> floor electrical riser hole in wall (low down towards lift side); 3 <sup>rd</sup> floor North, Comms riser, mastic slumped from sprinkler pipe hole; 3 <sup>rd</sup> floor electrical riser hole in wall (low down towards lift side); 2 <sup>nd</sup> floor North gas pipe riser hole around flexi pipe; 2 <sup>nd</sup> floor North, Comms riser, mastic slumped from sprinkler pipe hole; Ground floor Comms room, hole around data cable above door; Seal puncture hole in duct, ground floor escape corridor from secondary stairway

Hazards Introduced by Contractors			
Identified Hazard	Yes	No	Comments
Fire stopping to required standards		✓	8 <sup>th</sup> floor South Comms cupboard, fire stopping above doors; 6 <sup>th</sup> floor North, air con riser above doors; 5 <sup>th</sup> floor electrical riser hole in wall (low down towards lift side); 3 <sup>rd</sup> floor North, Comms riser, mastic slumped from sprinkler pipe hole; 3 <sup>rd</sup> floor electrical riser hole in wall (low down towards lift side); 2 <sup>nd</sup> floor North gas pipe riser hole around flexi pipe; 2 <sup>nd</sup> floor North, Comms riser, mastic slumped from sprinkler pipe hole; Ground floor Comms room, hole around data cable above door; Seal puncture hole in duct, ground floor escape corridor from secondary stairway
Integrity of fire compartments maintained		✓
